## Clearing sludge from a retention basin

Our client needs to drain the sludge from the retention basin on its production site every year, to ensure its plant runs smoothly, while complying with the standards for discharges into the natural environment.

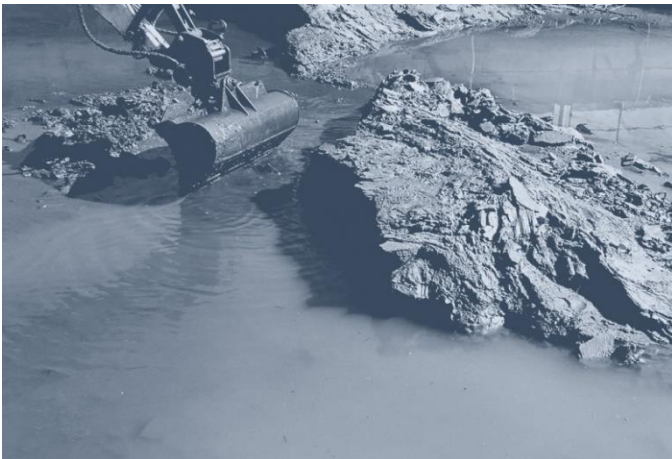
The basin contained 850 m<sup>3</sup> (1 112 yd<sup>3</sup>) of mineral sludge, which was too harsh to use a conventional method, such as a centrifuge or a mobile press filter.

CTP environnement suggested pumping and dewatering this sludge using a more suitable technique of dewatering with a geotextile membrane. The very hard sludge at the bottom of the tank required the use of an appropriate power shovel.

With several geotextile membranes, measuring 120 m<sup>3</sup> (157 yd<sup>3</sup>) arranged over a specific and specially created area, the work was carried out successfully in the summer.

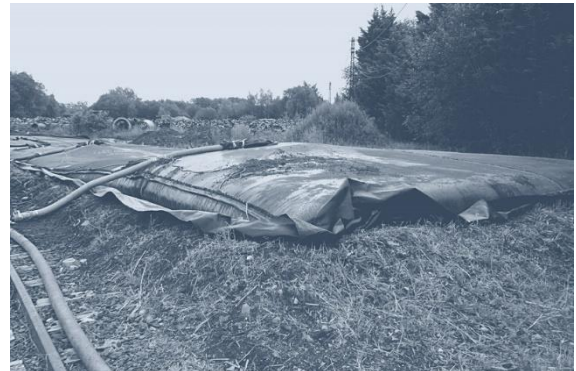
**In the end, all the sludge was removed from the tank and the hard sludge was stored alongside the dedicated area for the dewatering membranes.**
